MISSISSIPPI ENVIRONMENTAL GEOLOGY

David T. Dockery III and David E. Thompson

Mississippi Department of Environmental Quality
Office of Geology
Second Edition, 2019

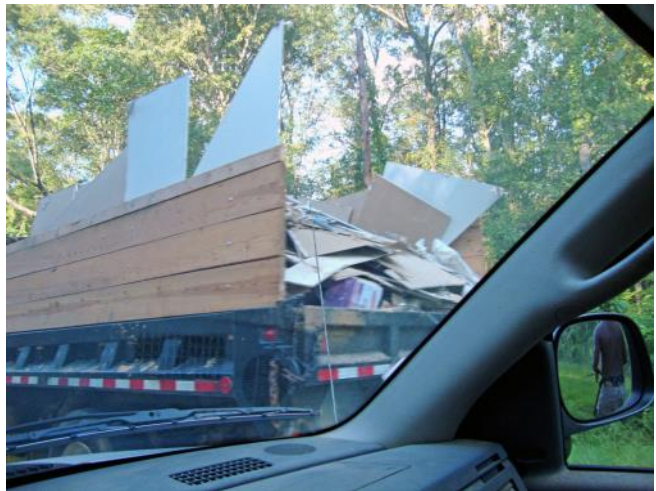
Figure 371. Dump truck, using sheet rock as extended side boards, drops debris along Pinehaven Road in Clinton, Mississippi. Wind can easily lift sheet rock from a truck bed at road speeds of 40 to 50 miles per hour. Picture (digital; Image 2102) was taken on August 3, 2011.

1. Heavy commercial traffic on local roads, including eighteen-wheelers with waste.
2. Falling debris from trucks and trailers. Haulers should cover their loads, but sometimes do not (**figures 368-371**).
3. Frequent flat tires from roofing tacks, nails, screws, and other sharp objects.
4. Destruction of local road surfaces from heavy truck traffic.
5. Liquid waste draining from poorly maintained truck beds.
6. Unauthorized offsite and nearby dumping from those who miss the closing hour or find that the facility will not accept their refrigerator or air conditioner.

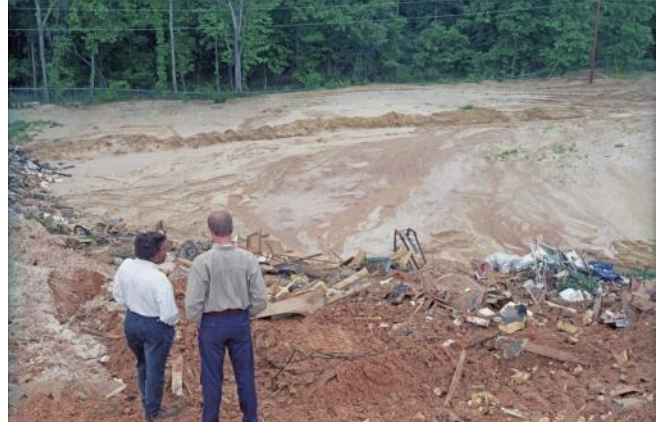
Figure 372. MDEQ personnel view sediment runoff at a class I rubbish site, which entered local streams. Picture (color negative 438-21; Image 2091) was taken on April 21, 1998.

7. Noise pollution similar to the sound of an ongoing construction site.
8. Inadequate dust control.
9. Uncontrolled sediment runoff and erosion, potentially affecting adjacent landowners (**figures 372-374**).
10. Inadequate odor control from uncovered solid waste (**figures 375-377**).

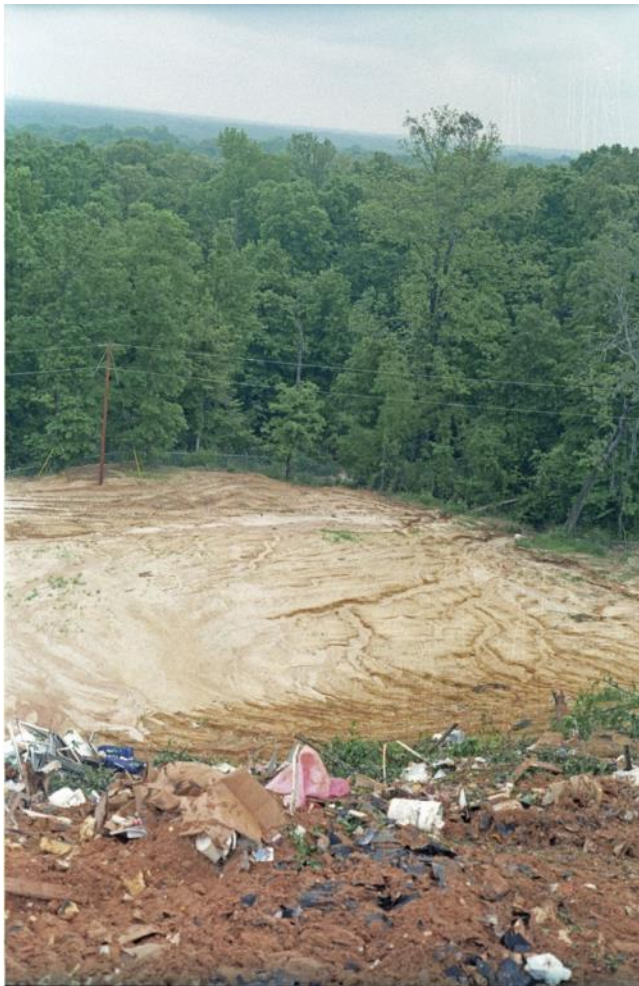
Figure 373. Lofty view above a class I rubbish site, demonstrating eroded gullies and absent controls for adequate storm water and sediment runoff. Picture (color negative 438-24; Image 2092) was taken on April 21, 1998.

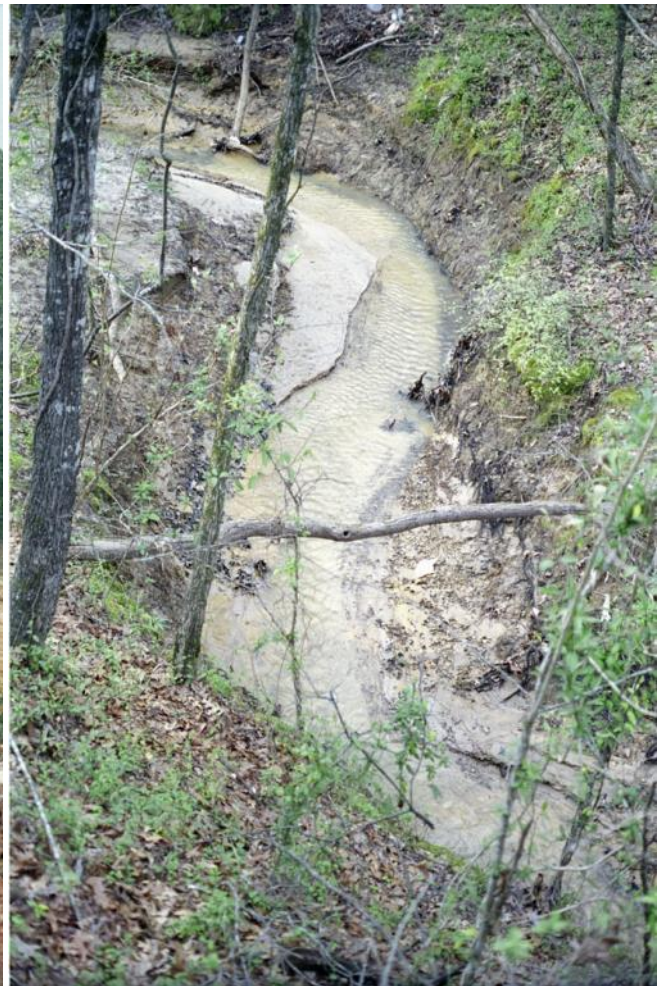
Figure 374. Uncontrolled sand deposition from a rubbish site into a creek ravine that was formerly a clay-bottom. Picture (color negative 436-12; Image 2093) was taken on March 18, 1998.

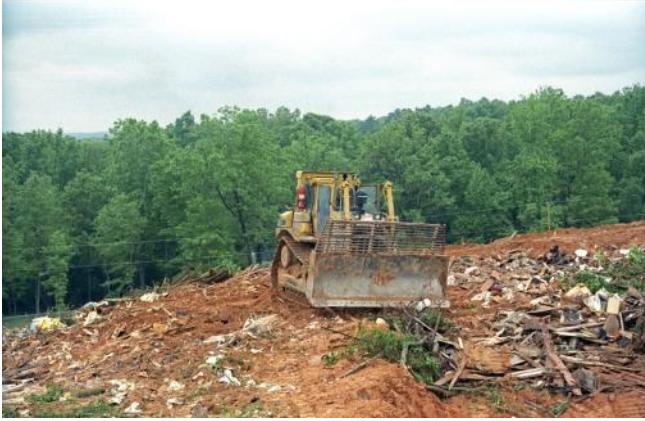
Figure 375. Construction debris at a class I rubbish site. Picture (color negative 438-20; Image 2094) was taken on April 21, 1998.

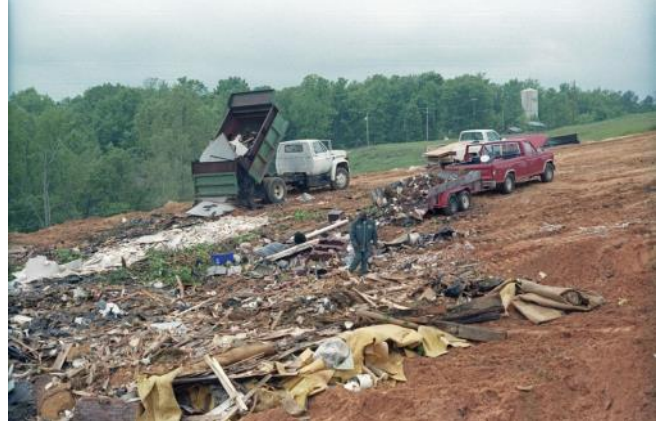
Figure 376. Sheet rock is common at rubbish dumps. Picture (color negative 438-19; Image 2095) was taken on April 21, 1998.

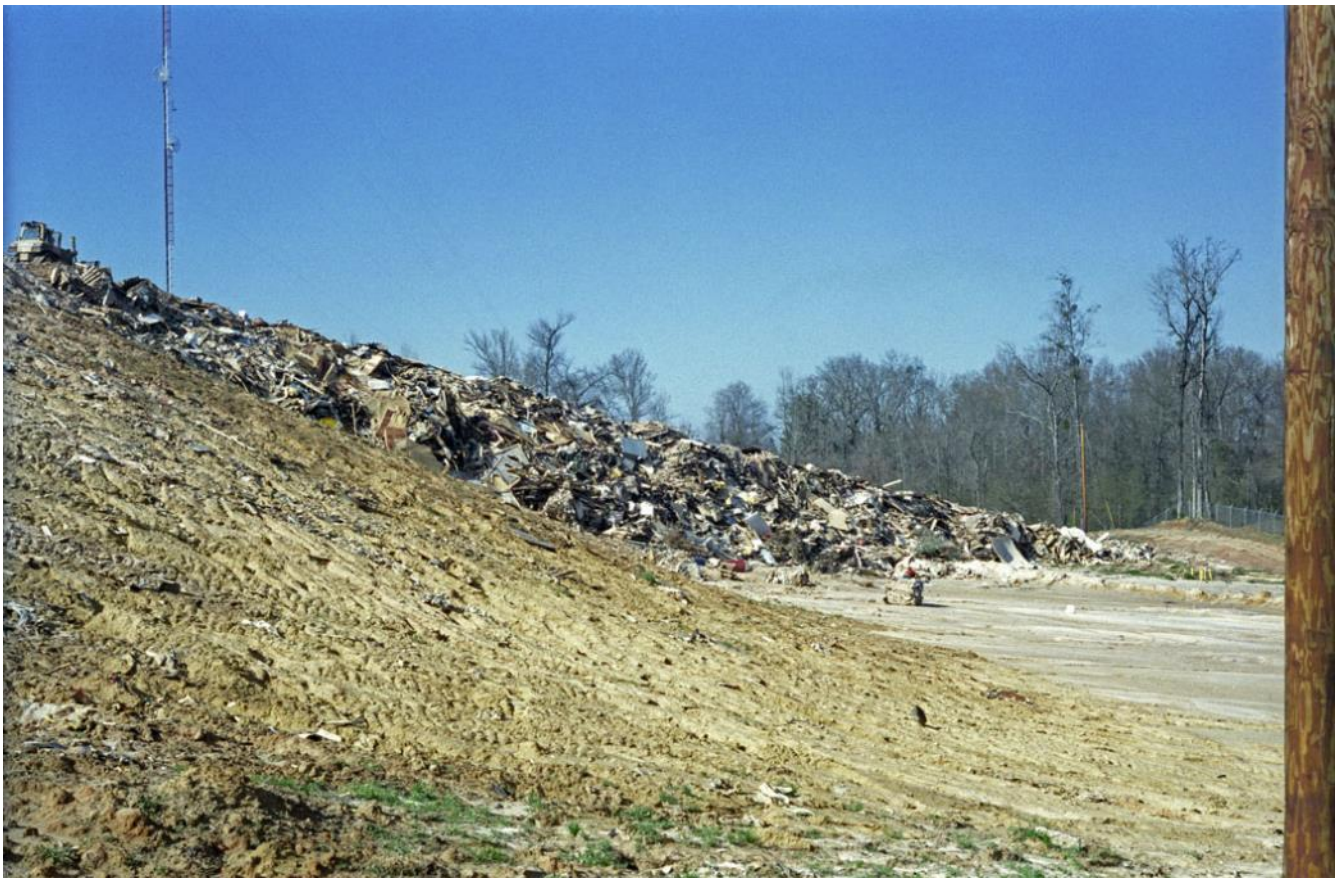
Figure 377. A thick layer of debris on a landfill slope. Picture (color negative 436-7; Image 2097) was taken on April 21, 1998.

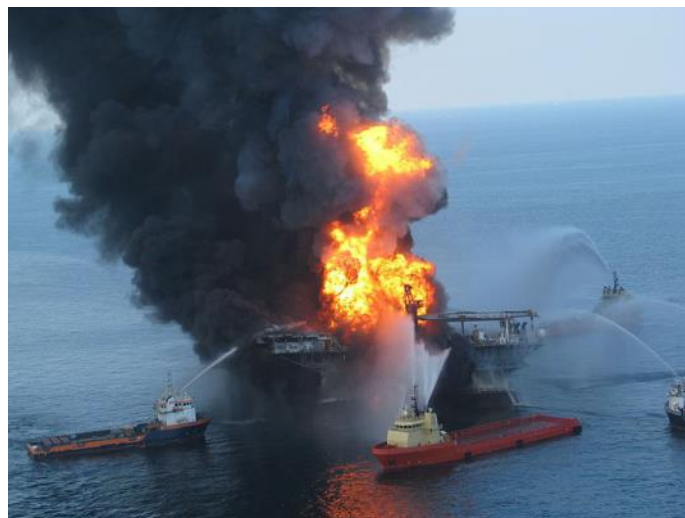
Figure 378. Fire on the mobile offshore drilling unit Deepwater Horizon is battled by platform supply vessels. This picture was taken by the crew of a Coast Guard MH-65C Dolphin Rescue helicopter on April 21, 2010. Image 2109.

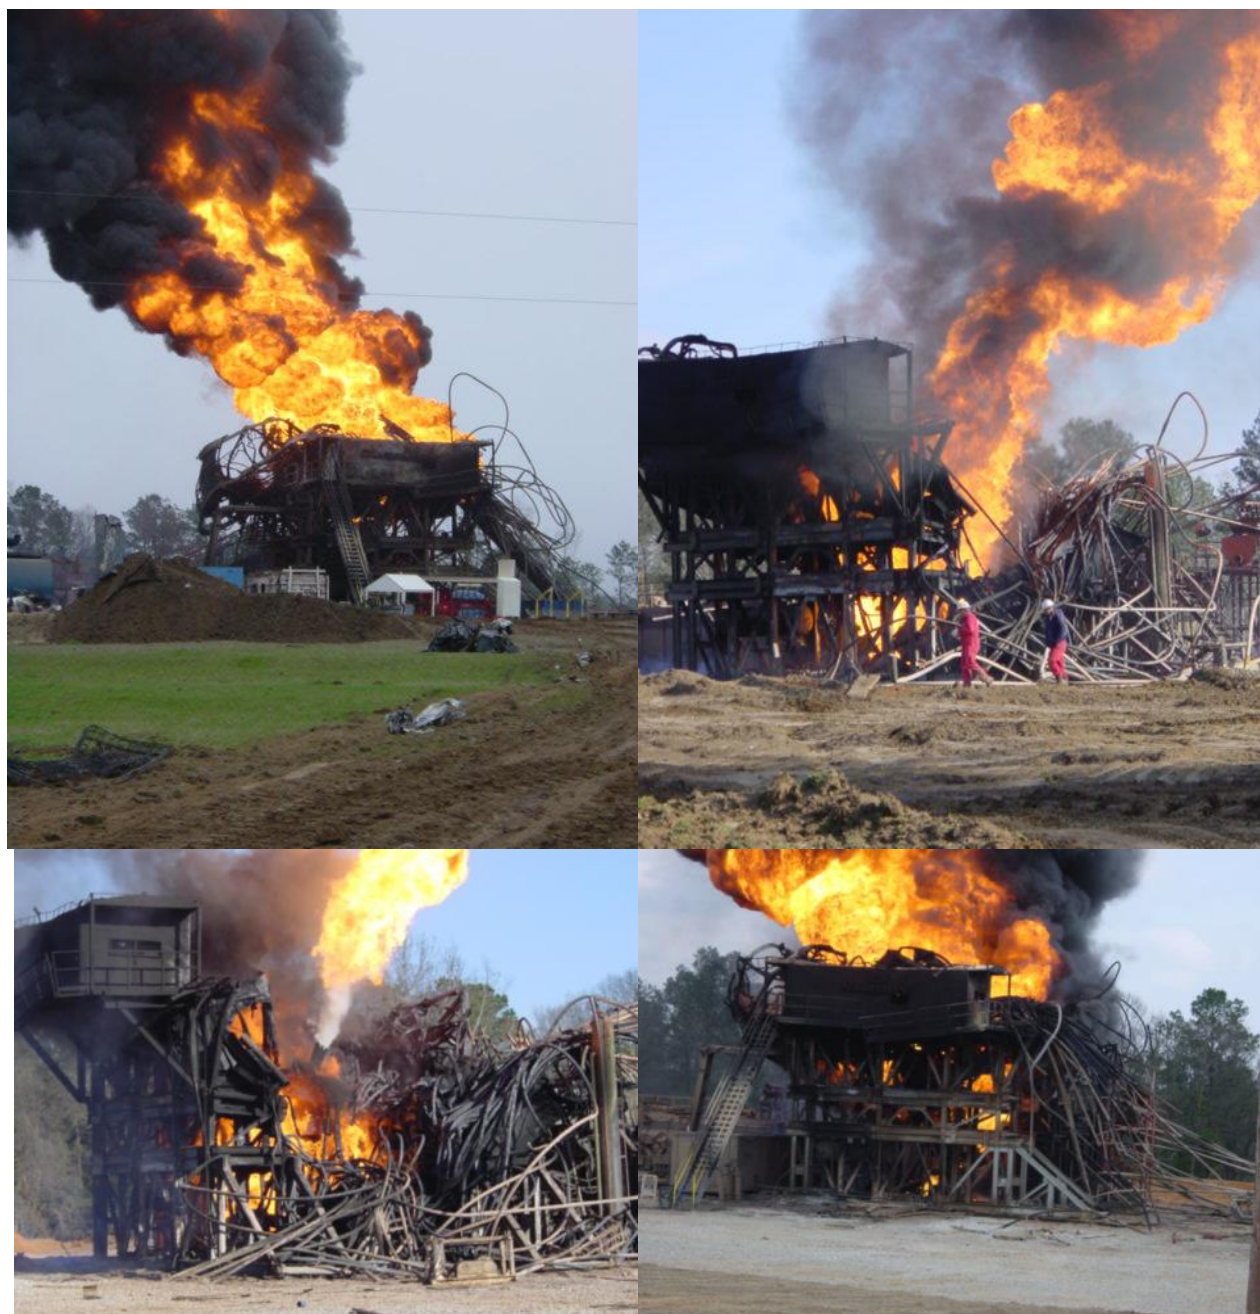
Figure 386. The Bean Resources #1 Beard 29-7 well blowout in Wayne County. Pictures (digital; Images 2117-2120) from Mike Spooner.

the crew scurrying around the drill floor where drill mud was spewing across the shale shaker at an abnormally high rate. He ordered the well shut in. When Magee went to the trailer to call the company, he heard a loud noise and looked up to see joints of casing spewing up the derrick. The tool pusher closed the blind rams as the crew fled the rig. The rams held, catching three joints of casing sticking 90 feet in the air. After the manifold pressure stabilized at 2600 pounds per square inch, the blind rams were opened again, hoping the casing would slide back down the hole. The casing did move down on the first attempt, but, on the third attempt, the casing came flying up, creating balls of fire as it crashed against the derrick.

After several joints of casing were blown from the hole, the well began blowing mud and gas with a thunderous noise. Magee made his way to the accumulator near the rig, as the crew yelled for him to get away, and started closing the valves. The flow stopped when he closed the blind rams. After a moment of silence, the flow resumed with a roaring gas geyser of possible deadly sour gas. Flares were fired at the gas plume, which ignited,

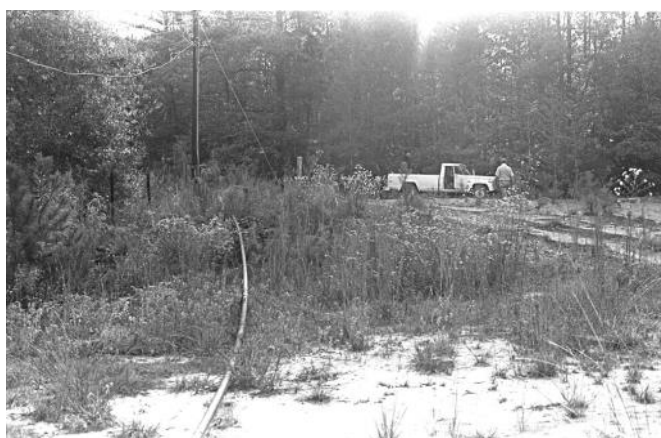
Figure 388. Salt water line from the North Yellow Creek Field leading to a local creek. Picture (negative 203-9; Image 2122) was taken in October of 1978.

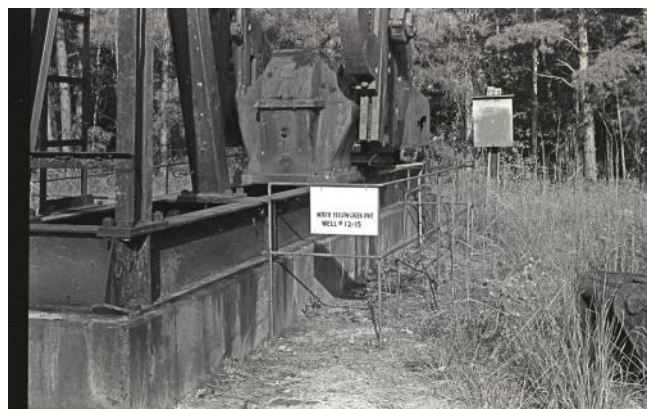
Figure 387. Producing well in North Yellow Creek Field in Wayne County, Mississippi, adjacent to a salt water line draining into a local creek. Picture (negative 203-6; Image 2121) was taken in October of 1978.

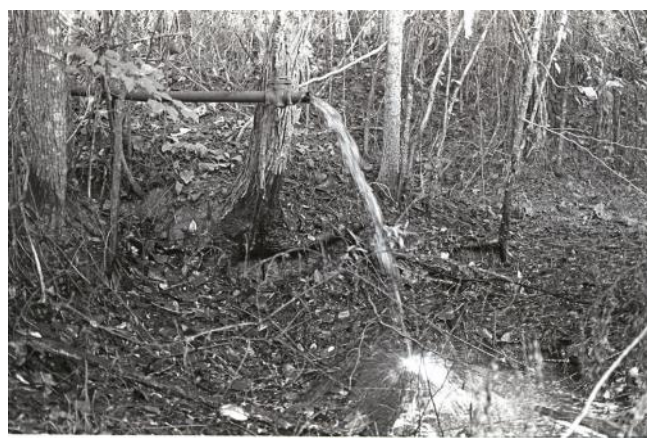
Figure 389. Salt water line draining onto the ground next to a local creek in North Yellow Creek Field. Picture (negative 203-7; Image 2123) was taken in October of 1978.

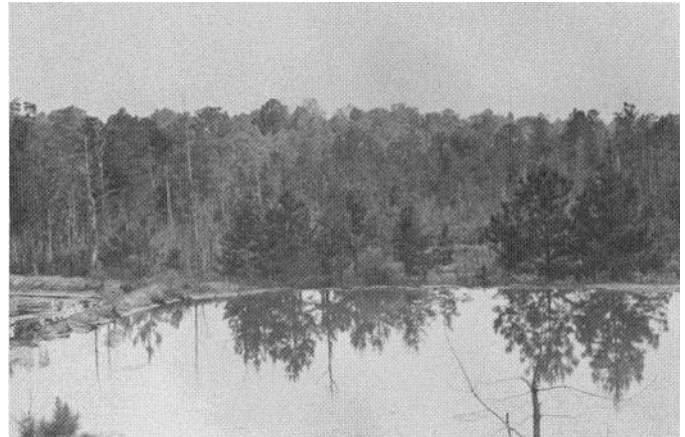
Figure 391. Overflowing salt water evaporation pit in West Eucutta Oil Field in Wayne County. Little Eucutta Creek is on the other side of the tree kill. Picture (Image 2125) was taken in August of 1973 and is from Baughman and McCarty, 1974, p. 285, fig. 5.

Baughman and McCarty illustrated tree kills next to leaking salt water evaporation ponds (**Figure 390**), a salt water evaporation pond overflowing into Little Eucutta Creek (**Figure 391**), salt water from an Alabama oil field being dumped into an evaporation pit in Eucutta Oil Field (**Figure 392**), and a rapidly seeping evaporation pond in Eucutta Oil Field (**Figure 393**). The practice of trucking Alabama salt water for disposal in Wayne County evaporation ponds was a result of the enactment of stronger environmental regulations in Alabama.

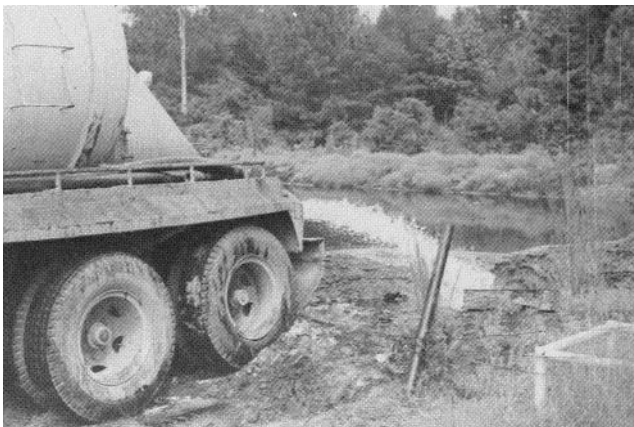
Figure 392. Tanker truck dumping salt water from an Alabama oil field into an evaporation pit in Eucutta Oil Field in Wayne County. Picture (Image 2126) was taken in August of 1973 and is from Baughman and McCarty, 1974, p. 286, fig. 6.

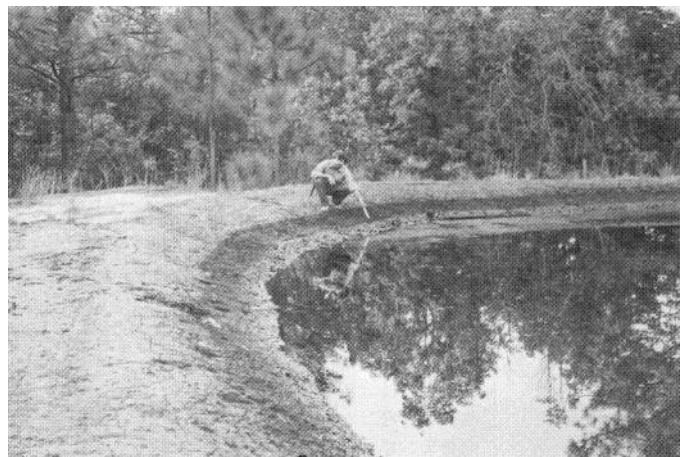
Figure 393. A salt water evaporation pit with a high seepage rate, and where the surface is completely covered in crude oil impeding evaporation, in Eucutta Oil Field in Wayne County. The knife edge is at the fluid level of the pit approximately three hours prior to this photograph. Picture (Image 2127) was taken in August of 1973 and is from Baughman and McCarty, 1974, p. 287, fig. 7.

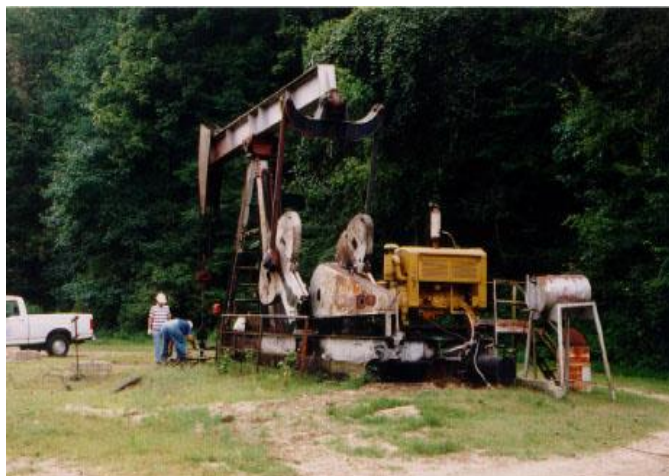
Figure 398. Collecting a brine sample at the well head.. Picture (Image 2130) from Ericksen et al., 1999, p. 14, fig. 2.

help minimize the amount of oil included in the samples. The preferred source of samples was straight from the well head (**Figure 398**), but this was not always possible because of oil/water emulsion that would not separate or for lack of a valve at the well head. Other sample sources, in order of preference, were (1) flow lines from the well head, (2) separators, (3) heater treaters, and (4) salt water storage tanks. The sample from the well head was first collected in a 5 gallon bucket with a valve at its base. After filling, the container was allowed to sit before the water was drained from the valve into a 4 liter sample container (**Figure 399**).

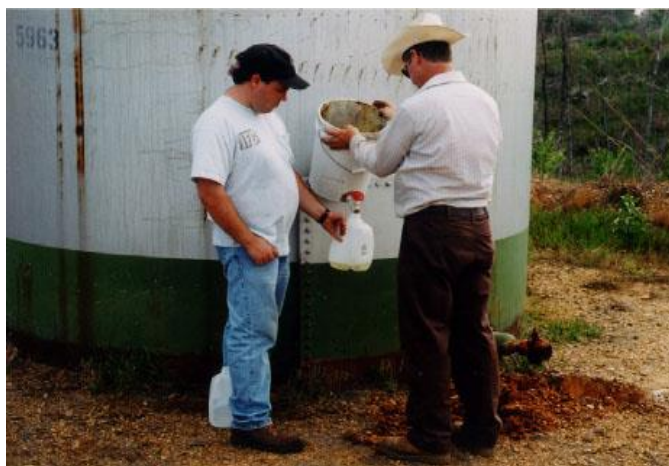
Figure 399. Transfer of brine sample into sample collection bottle. Picture (Image 2131) from Ericksen et al., 1999, p. 14, fig. 3.

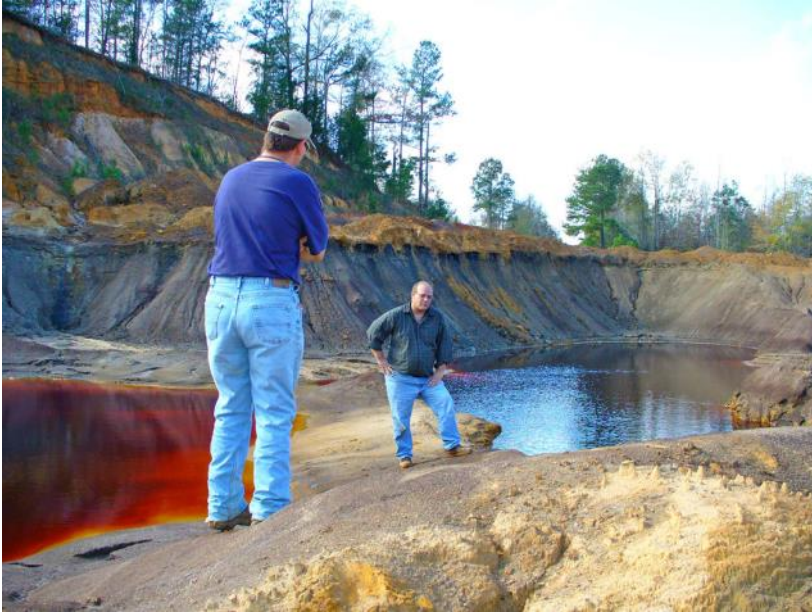
Figure 402. Leroy Strite (left) and Larry Strite (right) at the Easom Mine in the Bucatunna Clay in Smith County, Mississippi. Spring water draining off the top of the clay at left is blood red with minerals and/or sulfur-reducing bacteria. Picture (digital; Image 1723) was taken by Michael LaBelle on December 10, 2007.

Easom Mine in Smith County (**Figure 402**) found thorium levels of 20,690 ppm, about 3.5 times the average level. **Figure 403** shows an outcrop of the Bucatunna Clay on Highway 18 in Brandon.

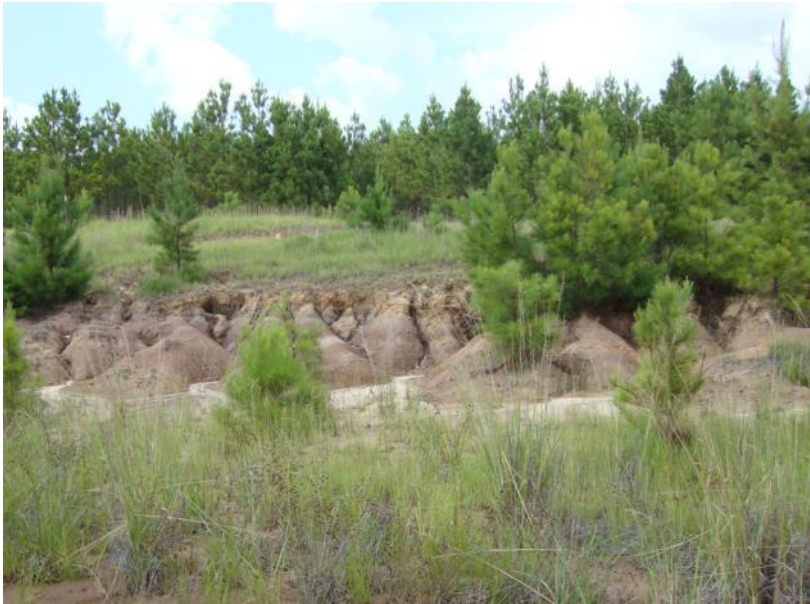
Figure 403. Outcrop of Bucatunna Clay on the north side of Highway 18 across from Brandon High School. Picture (digital; Image 2139) was taken on July 27, 2011.

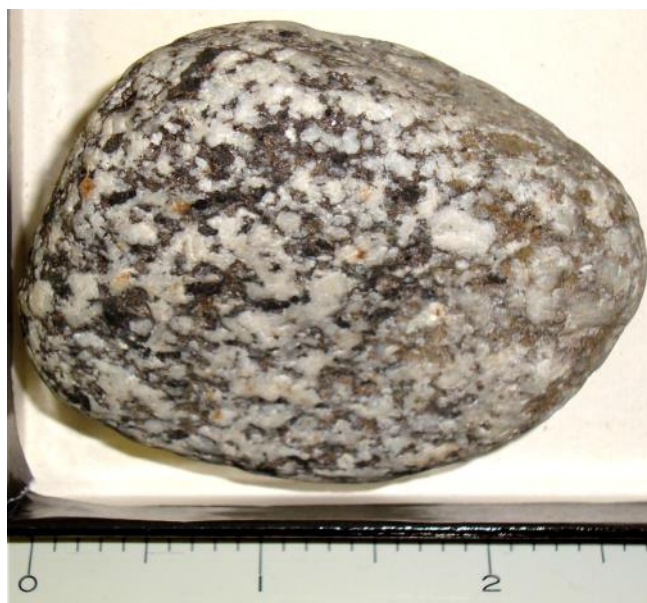
Figure 409. Granite pebble collected by Paul Parrish from the Mississippi River gravel bar at Rosedale, Mississippi. Picture (digital: Image 1778) was taken on November 17, 2010; scale in inches.

Plain, which occur within a hundred feet of the surface. One in ten pebbles of Mississippi River gravel is composed of granite (**Figure 409**). Similar glacially-derived materials, ground from granitic rocks of the Canadian Shield, underlie the farm lands of Iowa, where all the state's counties are zoned in Level 1 (see **Figure 395**). Radon levels are so high in that state that cities such as Iowa City have passed requirements for radon-resistant construction in new homes.

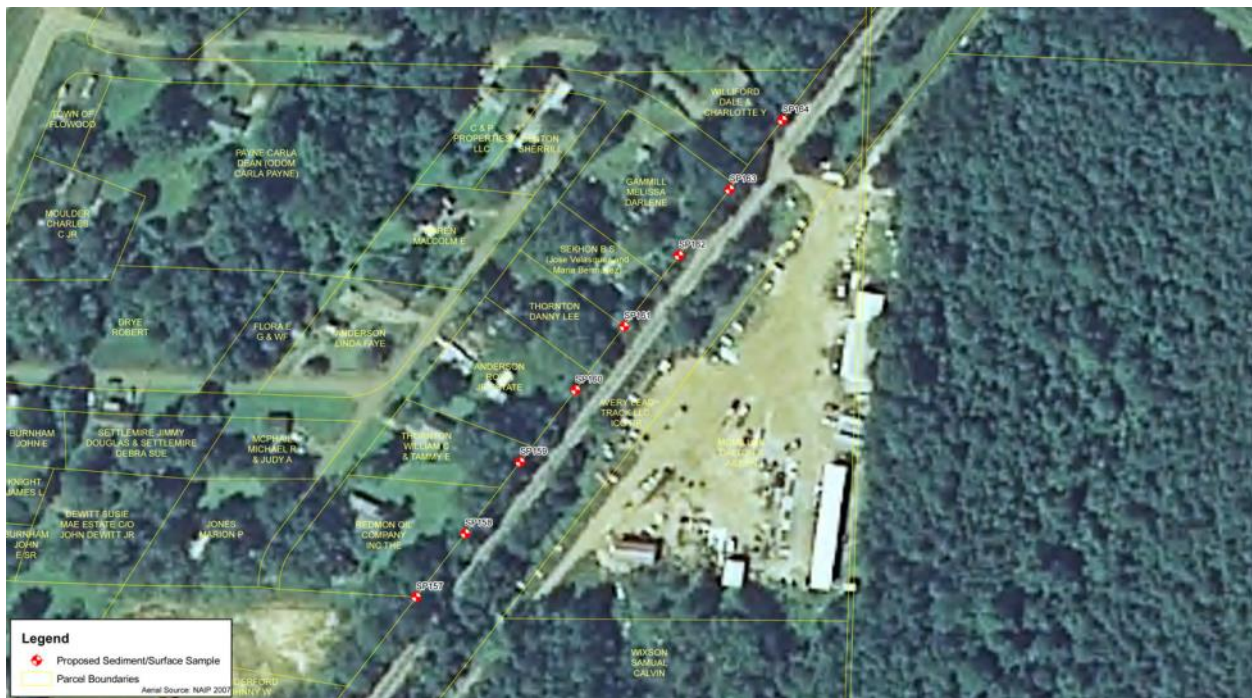
Figure 413. Location of the Sonford Superfund site (triangle with McMillon, Dalton, & Aileen property) on an areal photograph with property lines in yellow. Image 2148.

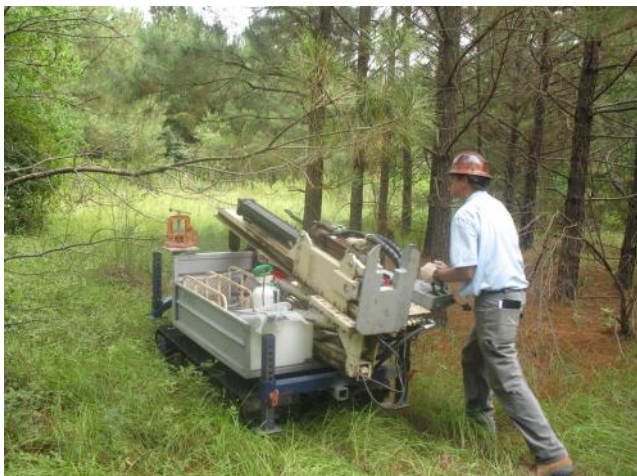
Figure 414. Navigating the direct push technology well installer across the Sonford Superfund site at Flowood, Mississippi. Picture (digital; Image 2149) was taken by Richard Ball on September 5, 2007.

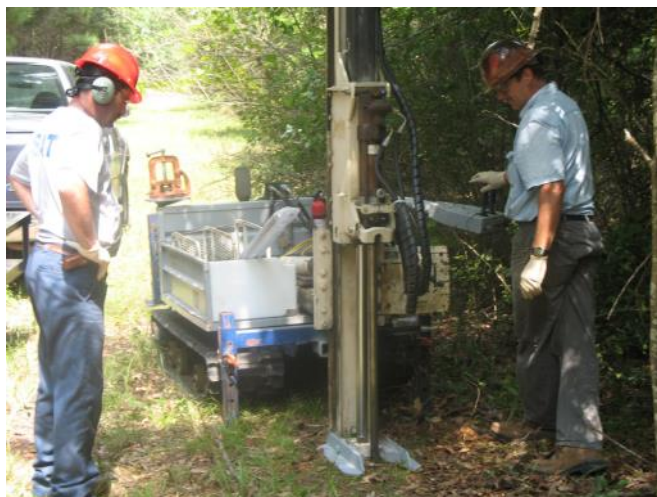
Figure 415. Water well installation at the Sanford Superfund site by workers from EPA's Southeastern Scientific Division using direct push technology. Picture (digital; Image 2150) was taken by Richard Ball on September 5, 2007.

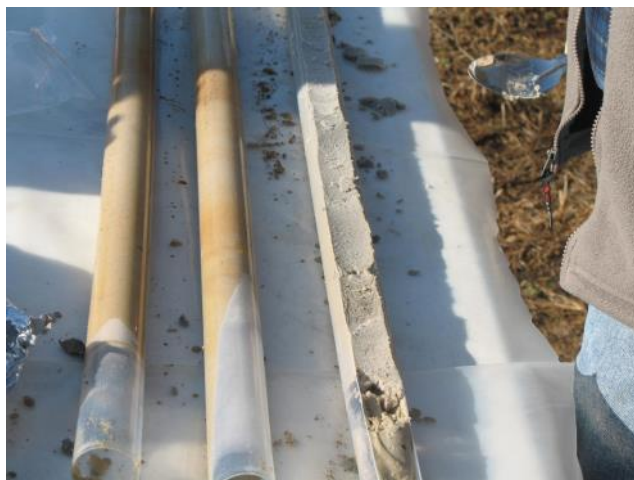
Figure 417. Two-inch cores of Pearl River alluvial sands taken by direct push technology on the Sonford Superfund site in Flowood, Mississippi. Picture (digital; Image 2152) was taken by Richard Ball on September 6, 2008.

site using direct push technology. **Figure 417-418** shows cores of the Pearl River alluvial sand.

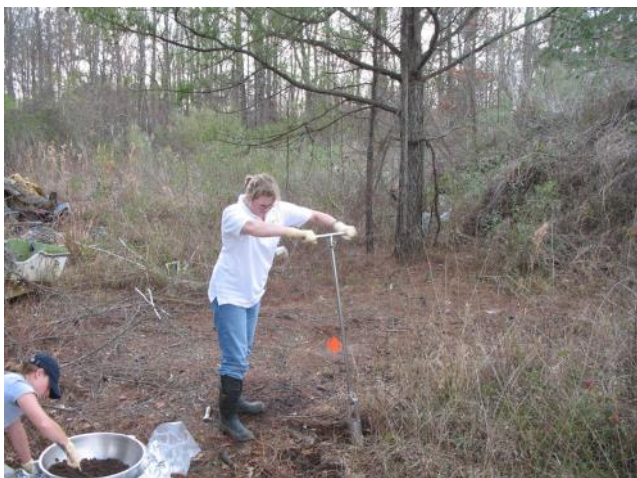
Figure 419. EPA workers taking soil samples with a hand auger on the Sonford Superfund site in Flowood, Mississippi. Picture (digital; Image 2154) was taken by Richard Ball on February 5, 2008.

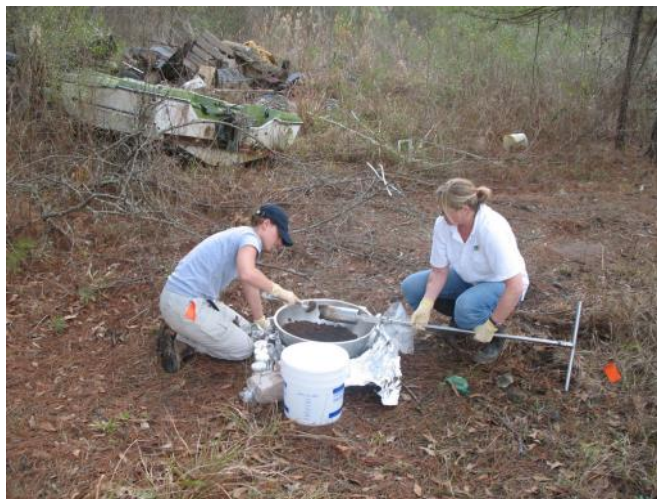
Figure 420. EPA workers taking soil samples on the Sonford Superfund site in Flowood, Mississippi. Picture (digital; Image 2155) was taken by Richard Ball on February 5, 2008.

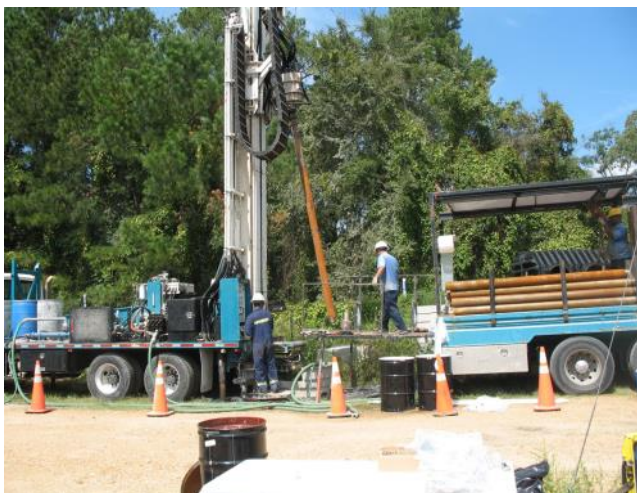
Figure 421. Rotosonic drilling rig adding another drill stem at the Sonford Superfund site in Flowood, Mississippi. Picture (digital; Image 2156) was taken by Richard Ball on September 10, 2008.

The Sonford site is high on the southeastern flank of Jackson Dome in an area where the top of the Moodys Branch Formation is higher than 225 feet above sea level (Baughman, 1971, pl. 3). Ground level at the site is 265 feet above sea level, and the top of the Moodys Branch Formation (and the base of the Yazoo Clay) is 28 feet below the surface. The "Log of Boring" done by Black & Veatch for the deep Rotosonic test hole (**figures 421-422**) in September of 2008 gave a general soil

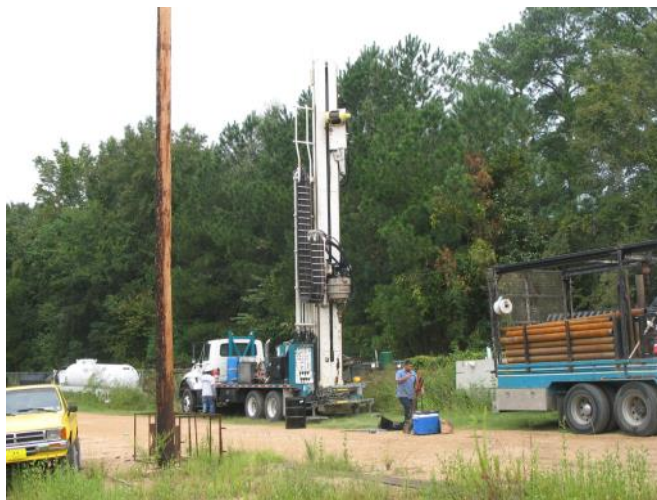
Figure 422. Rotosonic drilling rig and pipe truck parked at the Sonford Superfund site in Flowood, Mississippi. Picture (digital; Image 2157) was taken by Richard Ball on September 9, 2008.

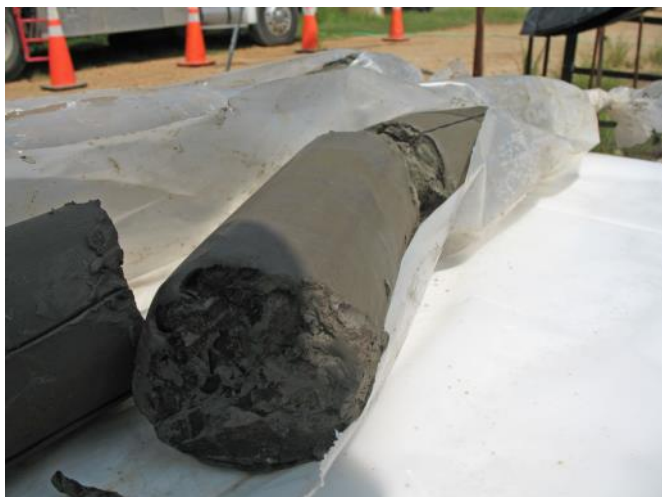
Figure 423. Four-inch core of the Cockfield Formation from the Sonford Superfund site in Flowood, Mississippi. Fossil plant remains can be seen where the core is parted. Picture (digital; Image 2158) was taken by Richard Ball on September 10, 2008.

Formation, (5) from 40-42 feet, a Shelby-tube sample with gray clay and silt of the upper Cockfield Formation and no fossil shells. Pictures of one of the Rotosonic cores that shows the typical lithology of the upper Cockfield Formation is in **figures 423-424**. An inter-core boundary was recognized in the Rotosonic Cockfield core from 210 to 220 feet, which consisted of 'Dark brown silty CLAY, tight, dry from 210 to 215 feet, and "Brown silty SAND, coarse-grained wet" from 215 feet and extending to 225 feet in the next core. This sand comprises the upper Cockfield aquifer. The Town of Flowood well #2, which is near

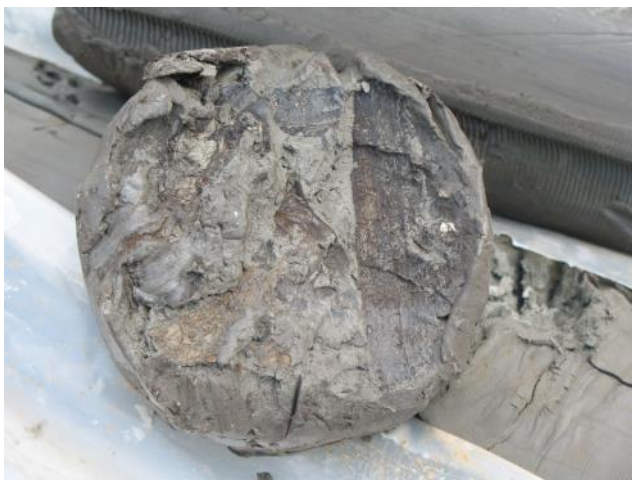
Figure 424. Fossil plant remains in a four-inch core of the Cockfield Formation from the Sonford Superfund site in Flowood, Mississippi. Picture (digital; Image 2159) was taken by Richard Ball on September 10, 2008.

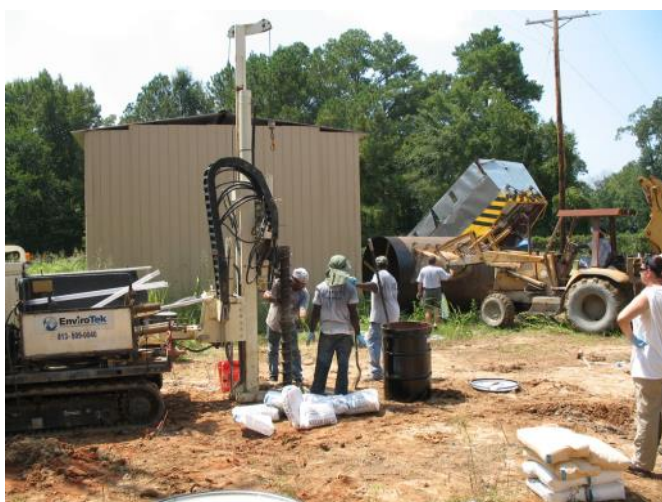
Figure 425. Installing an injection well with an auger rig at the Sonford Superfund site in Flowood, Mississippi. Picture (digital; Image 2160) was taken by Richard Ball on August 19, 2011.

within the aquifer. To accomplish this, a series of injection wells, monitor wells, and a central recovery well were installed in the most polluted area of the site (**figures 425-427**). The pilot test included three injection phases. The first was the injection of a surfactant to disperse the PCP-solvent mix in the groundwater (**Figure 428**). Dispersal of the PCP-solvent mix provided a greater surface area for oxidation. **Figures 429-430** compare the non-dispersed samples, where the PCP solution is strongly separated from the water, with the dispersed PCP ground-water mix. **Figure 431** shows the dispersed PCP mix in a half-inch-diameter bailer

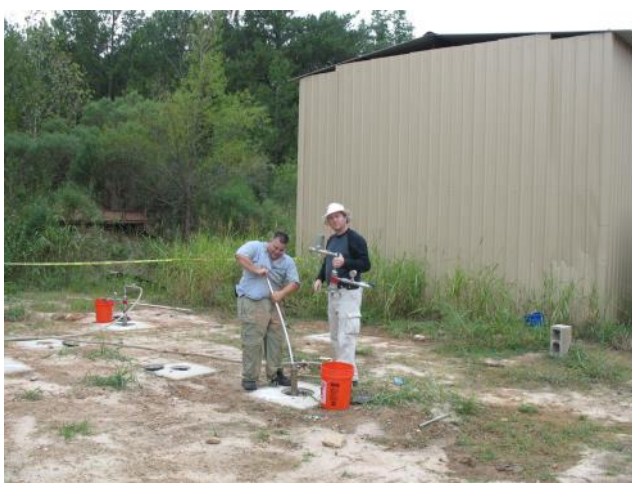
Figure 426. Installing tubing and well head for an injection well at the Sonford Superfund site in Flowood, Mississippi. Picture (digital; Image 2161) was taken by Richard Ball on September 19, 2011.

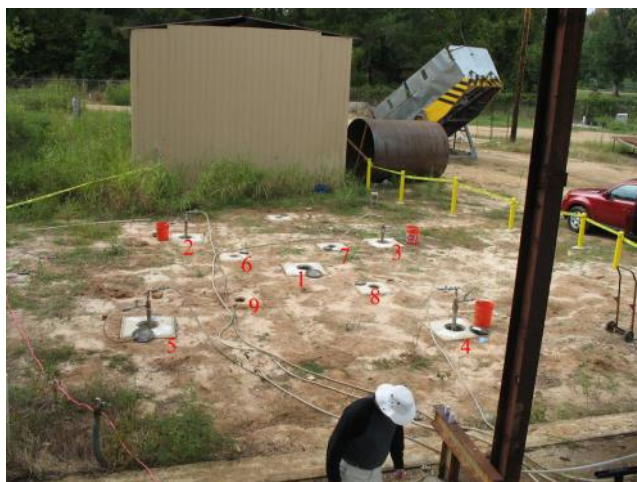
Figure 427. Well field for pilot test site at the Sonford Superfund site. Well 1 in the middle is the recovery well. On the four perimeter corners are injection wells 2-5. An interior set of four piezometer wells are numbered 6-9. Picture (digital; Image 2162) was taken by Richard Ball on September 19, 2011.

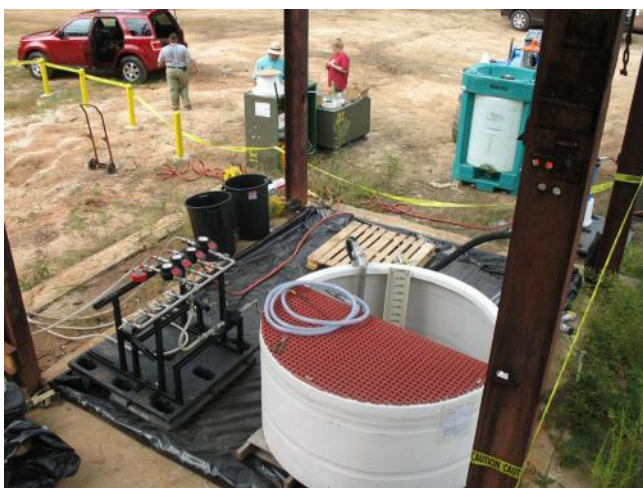
Figure 428. Holding tank and four lines leading to the injection wells. A surfactant is being injected into the Pearl River alluvial aquifer at this time. It is the first of three chemical mixes to be injected. Picture (digital; Image 2163) was taken by Richard Ball on September 19, 2011.

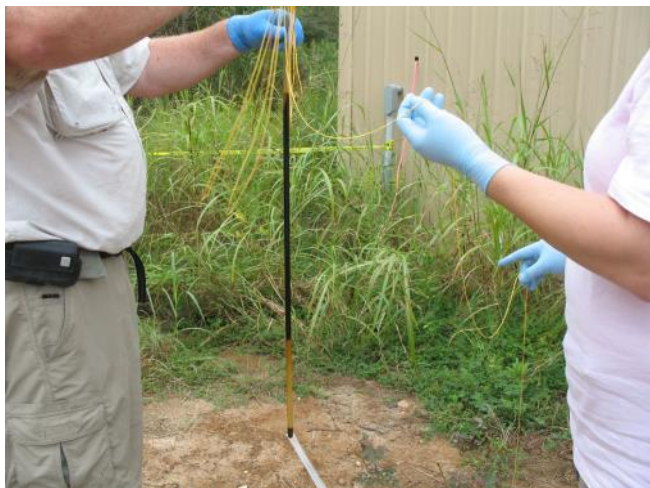
Figure 431. Half-inch bailer sample of the water column from a monitor well at the Sonford Superfund site in Flowood, Mississippi, taken after the injection of surfactant. The black column of pentachlorophenol (PCP) and solvent is partially mixed with the ground water. Picture (digital; Image 2166) was taken by Richard Ball on September 20, 2011.

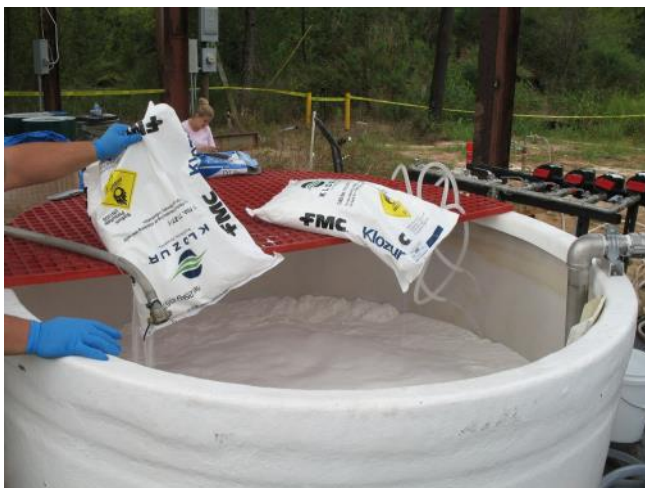
Figure 432. Mixing sodium persulfate, an oxidizer, to be injected into the ground water through four injection wells on the Sonford Superfund site in Flowood, Mississippi. Picture (digital; Image 2167) was taken by Richard Ball on September 20, 2011.

sample from a monitor well. The second injection phase was the injection of the oxidizer sodium persulfate (**Figure 432**). Sodium persulfate is preferred as a oxidant because of its high solubility in water and because its reaction with contaminants leaves less harmful side products. Sodium persulfate can degrade many environmental contaminants by itself, but it is generally used with other agents, such as heat, ultraviolet light, high pH, hydrogen peroxide, and transition metals to activate persulfate ions and generated sulfate radicals (SO_4^\cdot). The third injection phase was the injection of caustic soda (sodium hydroxide)

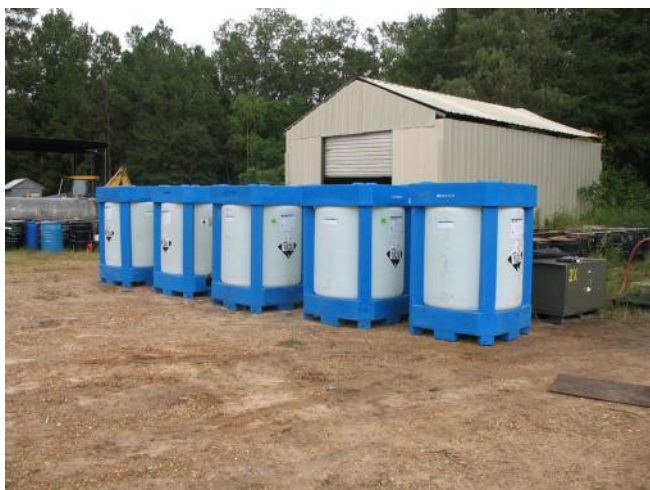
Figure 433. Industrial strength caustic soda (sodium hydroxide) on the Sonford Superfund site in Flowood, Mississippi, in preparation for injection into the polluted Pearl River alluvial aquifer. Picture (digital; Image 2168) was taken by Richard Ball on September 19, 2012.

(**Figure 433**). The purpose of the caustic soda was to increase the ground water pH to 14 or 15 (**Figure 434**) and react out the sodium persulfate to release oxygen. This reaction changes the PCP plume in the groundwater into a chloride (salt) plume, which is much less toxic. A report on the effectiveness of this pilot test is pending. Information of the Sonford Superfund site history given here is from the *Draft Remedial Investigation Report, EPA Contract #68-W-99-043* (February 2009), and information and pictures on the pilot test are from Richard Ball of the Mississippi Office of Pollution Control.

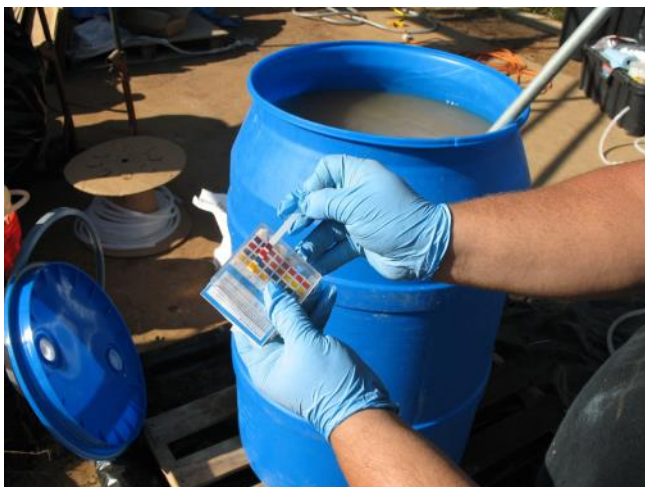
Figure 434. Testing ground water from the recovery well to make sure the sodium hydroxide injected through the injection wells has produced a pH of 14 or 15. The color match indicates a pH of 14. Picture (digital; Image 2169) was taken by Richard Ball on September 22, 2011.

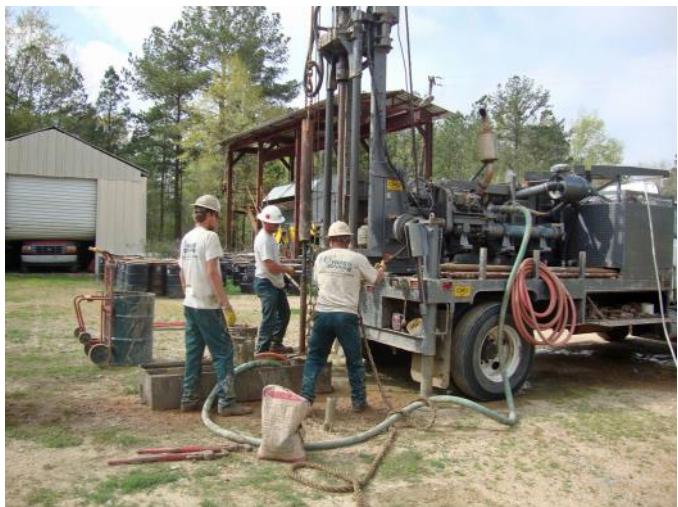
Figure 436. Hammering the split-spoon core tube into the ground at 18-20 feet below the surface at the second drill site on the Sonford Superfund site in Flowood, Mississippi. Picture (digital; Image 2218) was taken on March 15, 2012.

Split-spoon samples from test holes drilled at the disposal cell site on March 14 and 15, 2012, are shown in **Figure 435**. **Figures 436-437** show, respectively, driving (hammering) down the split-spoon core and core recovery. **Figure 438** shows the layout of the mat (partially unfolded in the picture) on which contaminated soil will be placed. **Figure 439** shows the excavation of soil from a residential yard contaminated with pentachlorophenol (PCP), which will be transported to the mat adjacent the permanent disposal site

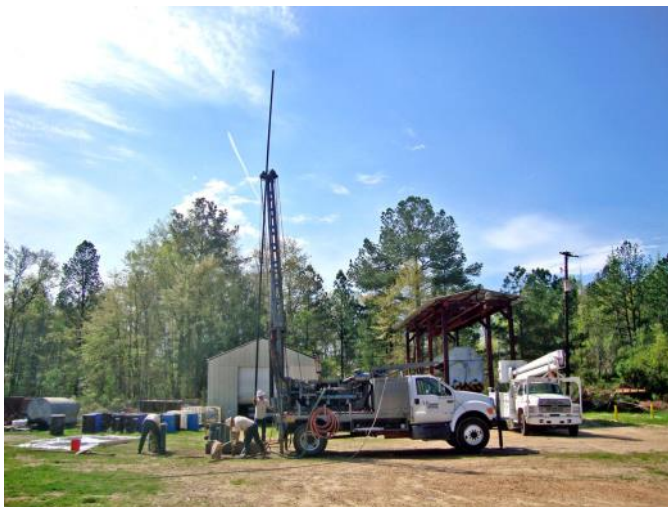
Figure 437. Recovering a split-spoon core from 38-40 feet at the second drill site on the Sonford Superfund site in Flowood, Mississippi. Picture (digital; Image 2219) was taken on March 15, 2012.

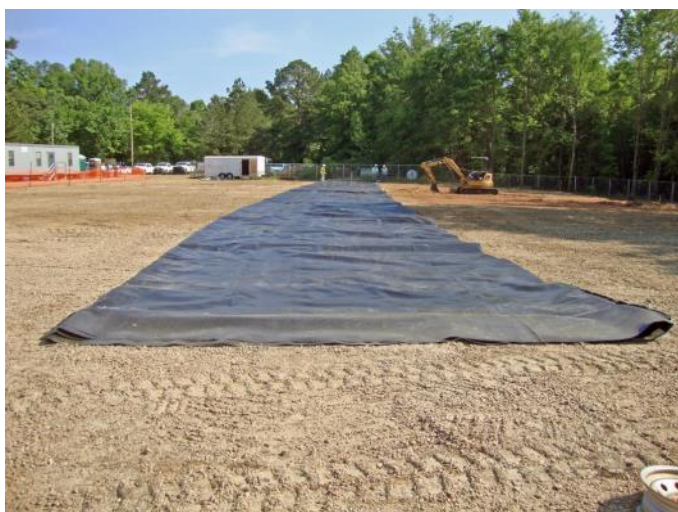
Figure 438. Workers are laying out and unfolding a very large mat at the Sonford Superfund site in Flowood, Mississippi, on which contaminated soil from an adjacent residential area will be placed before its permanent burial in a disposal cell on site. Picture (digital; Image 2220) was taken on April 13, 2012.

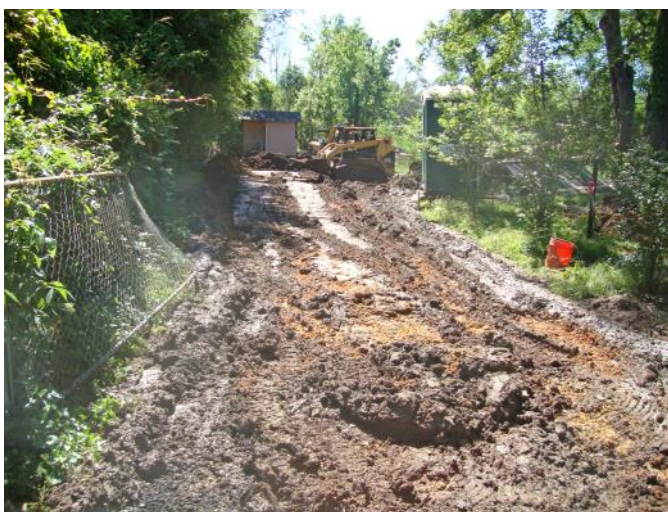
Figure 439. Digging up the yards of residents near the Sonford Superfund site. The dirt excavated is contaminated with pentachlorophenol (PCP). It will be replaced with dirt "clean enough for children to eat." Picture (digital; Image 2221) was taken on April 18, 2012.

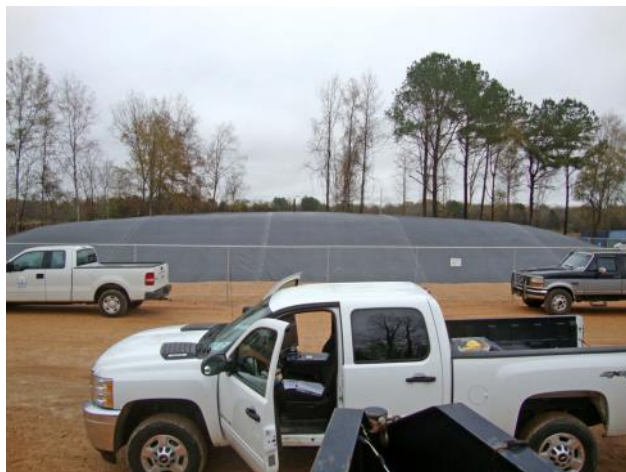
Figure 440. PCP contaminated top soil from neighborhood yards under tarp at the Sonford Superfund site. Picture (digital; Image 2271) was taken on December 5, 2012.

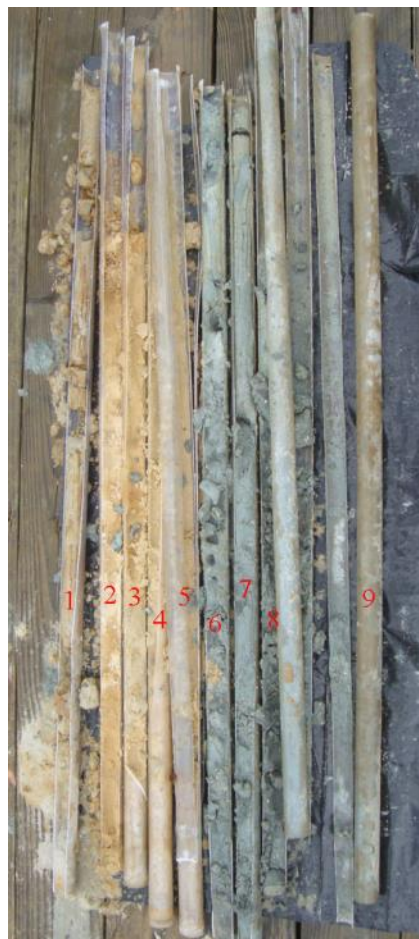
Figure 441. Direct-push 5-foot-long cores from the PCP plume area; core 1 is fill dirt, 2-5 alluvium, 6-9 Moodys Branch Formation. Picture (digital; Image 2272) was taken on December 5, 2012.

Once the LIF log was completed for a location, a track-mounted direct-push coring rig sampled the alluvial section at the same spot for laboratory analysis (**Figure 441**). **Figure 442** shows the operation of the direct-push LIF rig. **Figure 443** shows a LIF probe and a core from a depth of 10-15 feet with dark bands of PCP contaminants. The LIF log printout is given in **Figure 444** and the 2010 PCP plume map in **Figure 445**.
